# Eastpointe Community Schools

2020 Facility Assessment Overview

October 26<sup>th</sup>, 2020

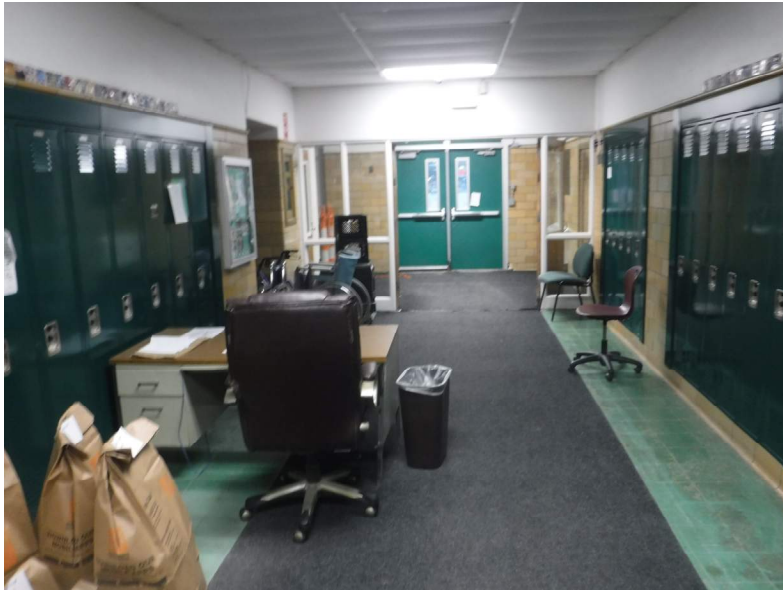
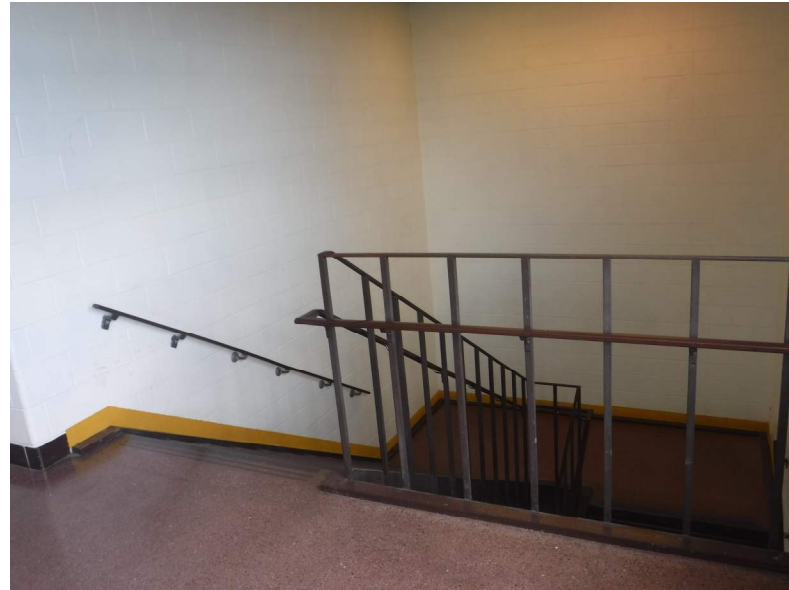
- **Safety & Security:** unsecured entrances, window security films, two-way public address systems, proper exterior lighting, high security locks on doors, low railings & other fall hazards

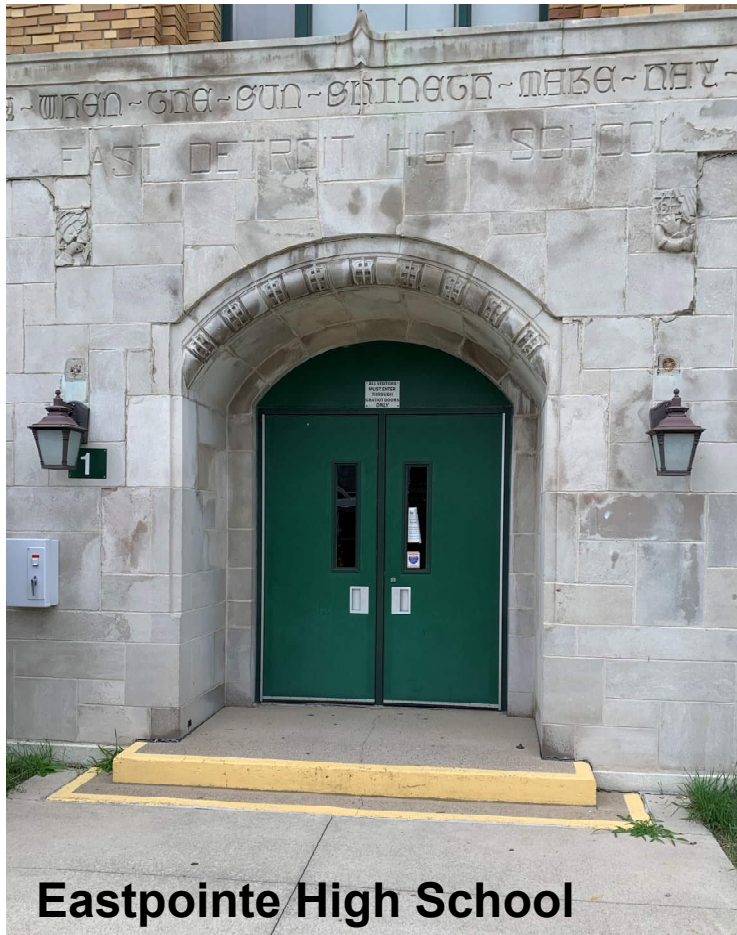
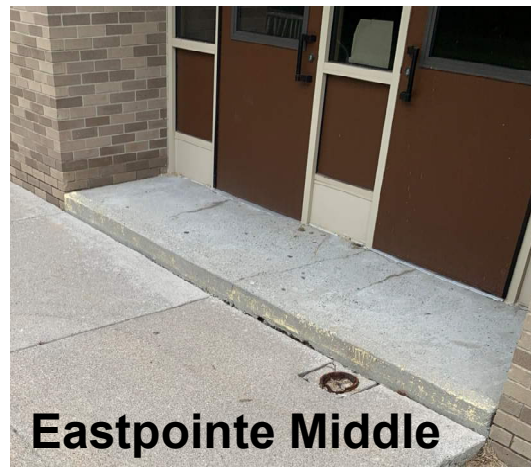
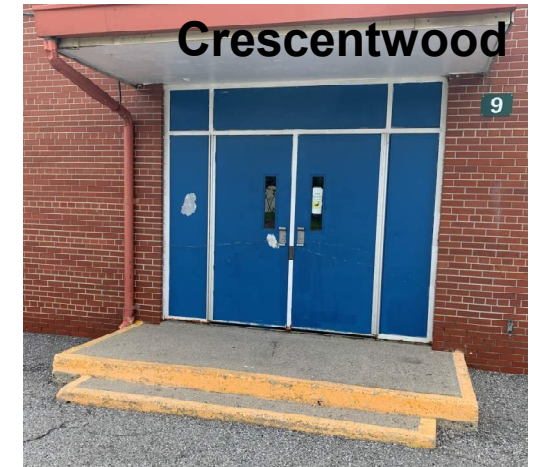
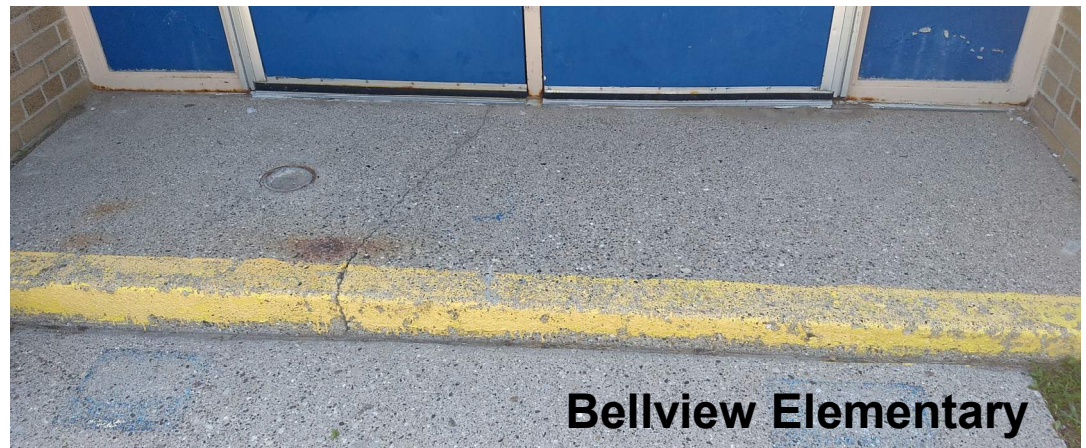
- **Steps at Egress Doors:** several doors throughout the district have raised steps

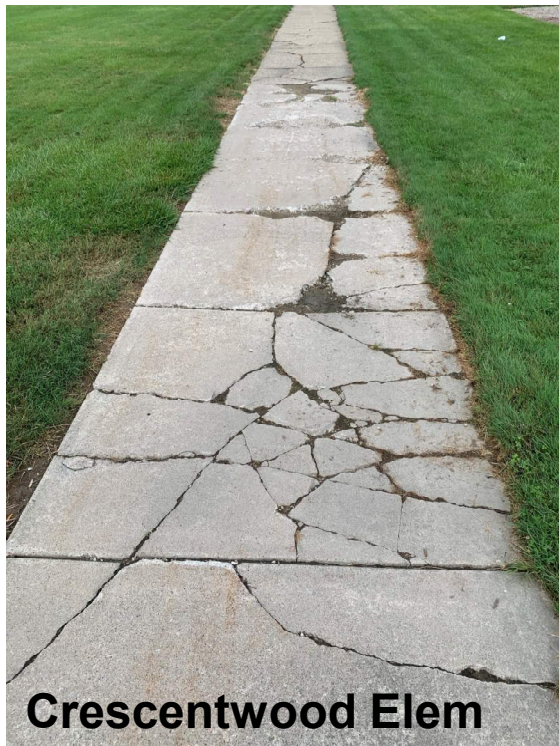
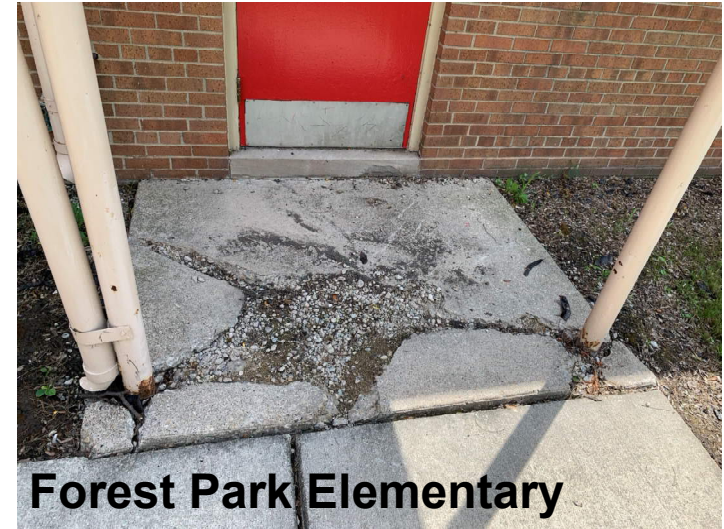
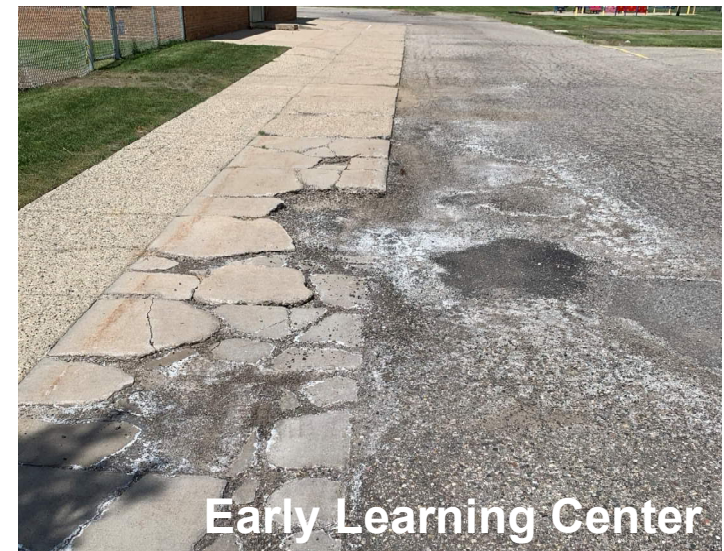
- **Damaged Paving & Sidewalks:**  
deteriorating parking and drives,  
heaving concrete walk areas, small  
and/or absent bus loops

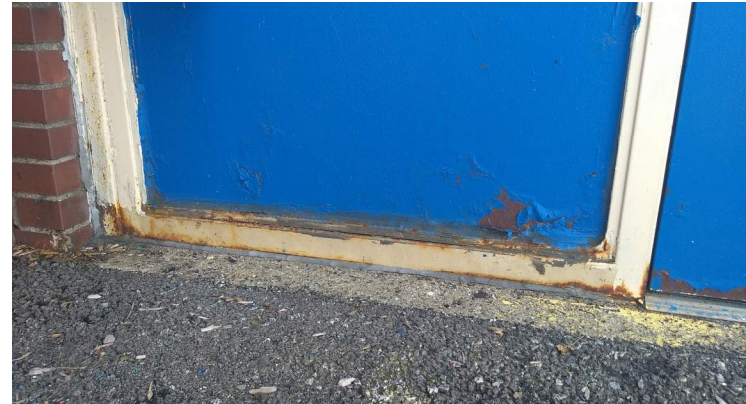
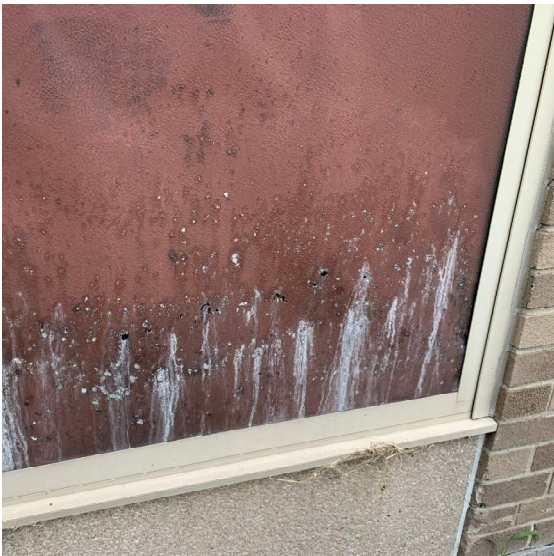
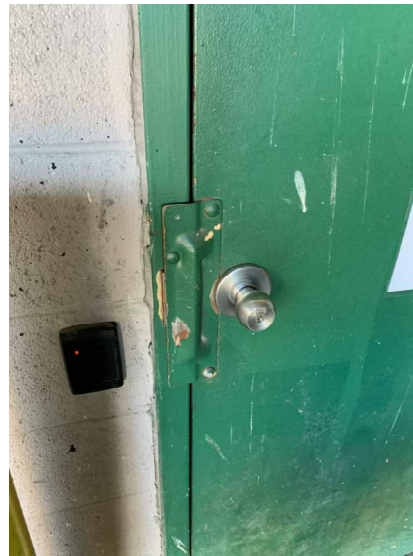
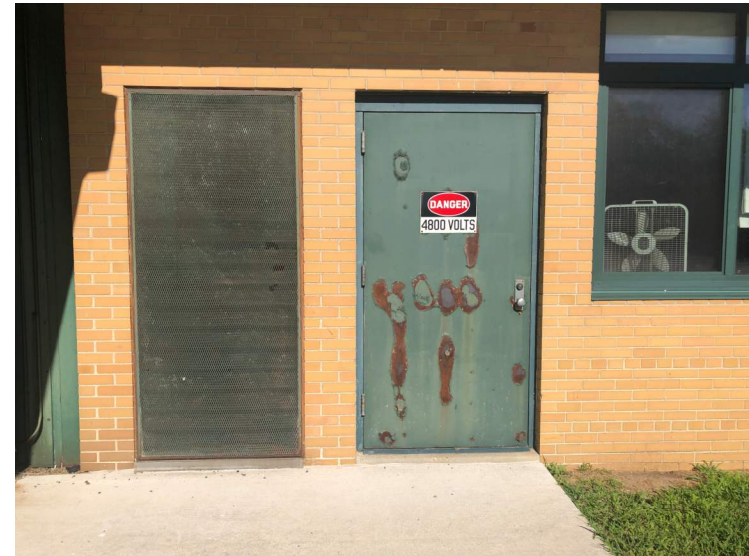
- **Some Exterior Doors and thresholds are in poor condition, have damaged / worn hardware, broken / rusted components & faded / peeling paint**

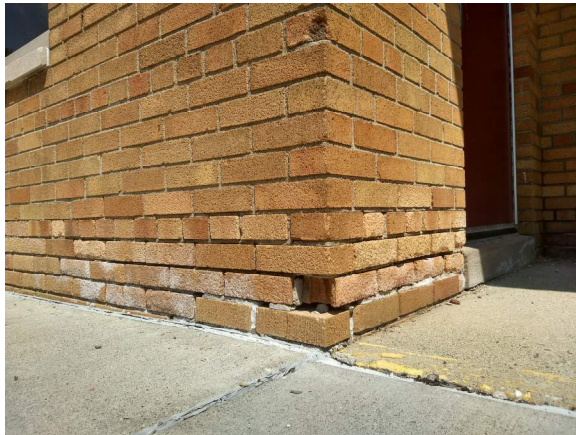
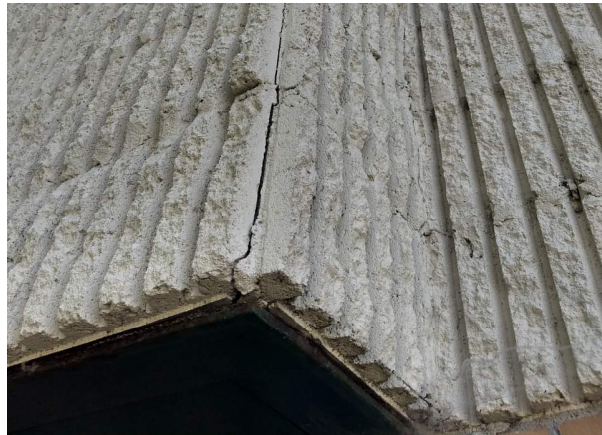
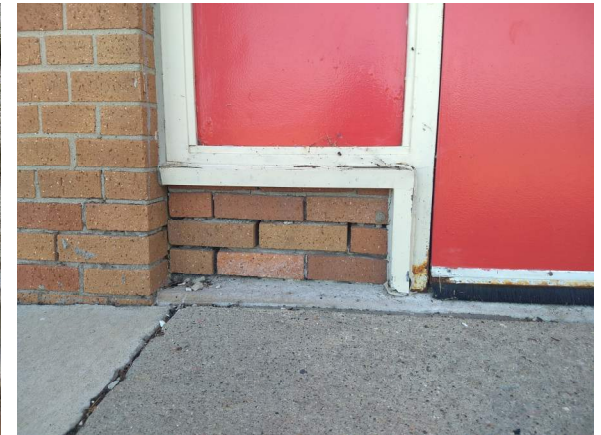
- **Exterior Envelope:** cracked masonry, deteriorated mortar & expansion joints, failing fascia panels, rusting / buckling steel lintels, wall cladding deterioration, water damaged soffits

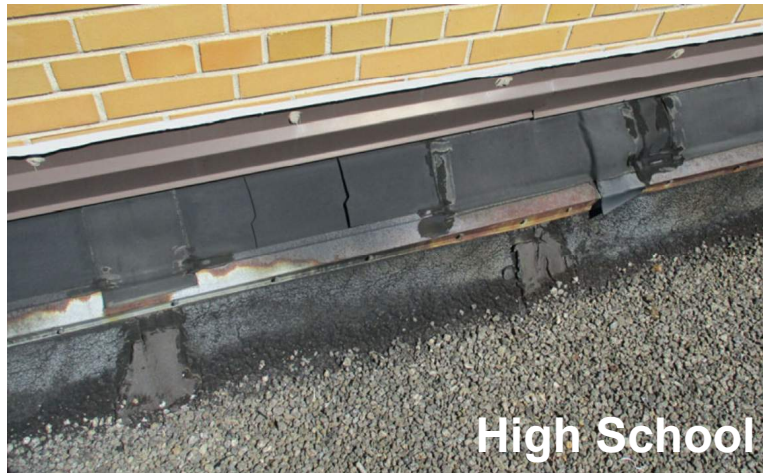
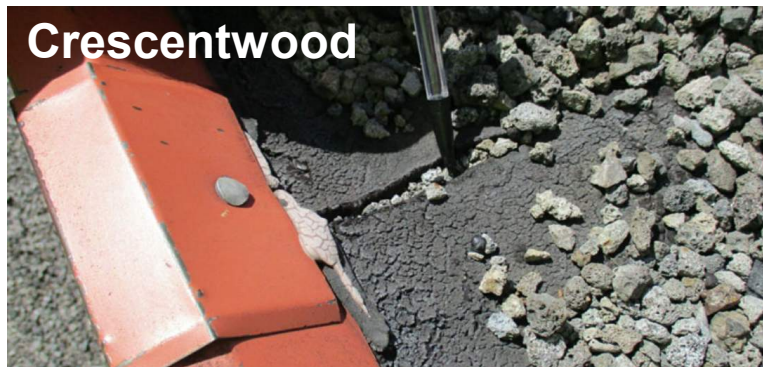
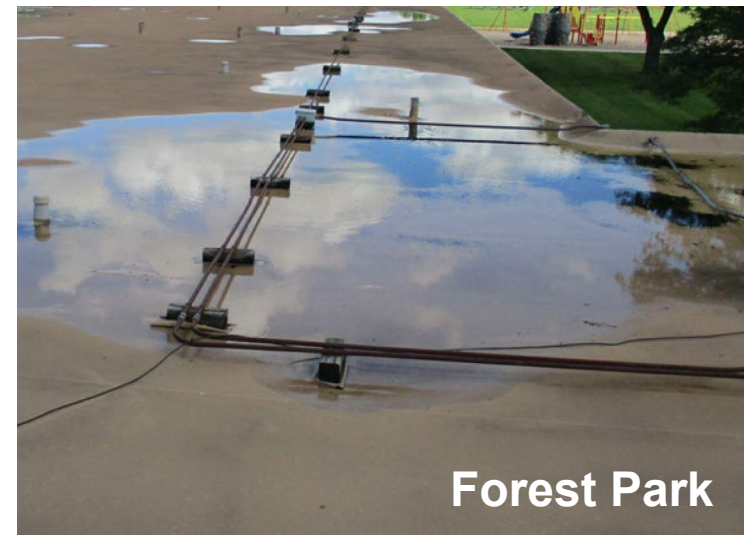
- **Roofing Issues:** deteriorating roof surfaces, split flashings, open joints, standing water, missing equipment

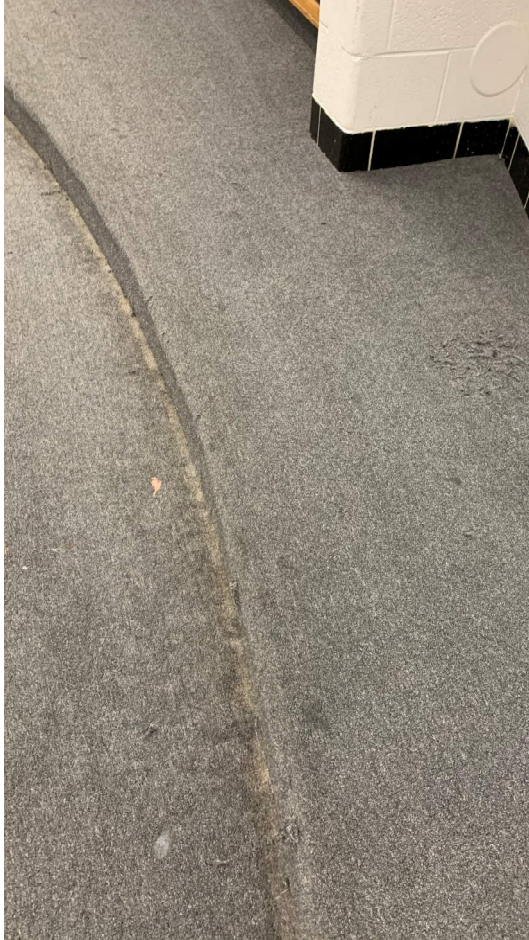
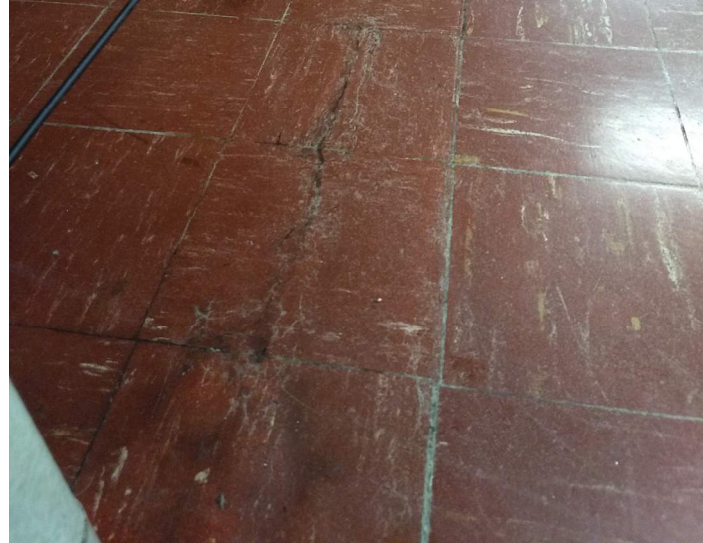
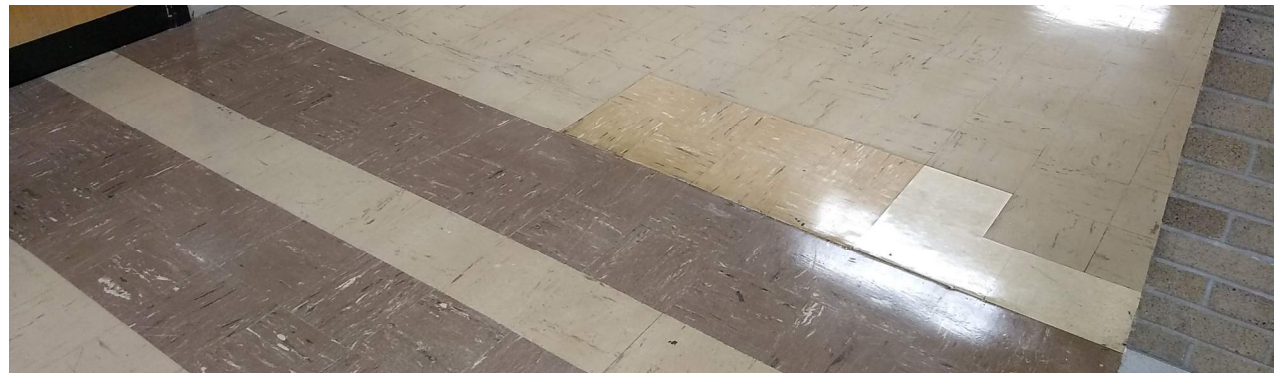
- **Floors:** cracked vinyl tile, stained carpet, broken and mismatched tiles, dirty grout

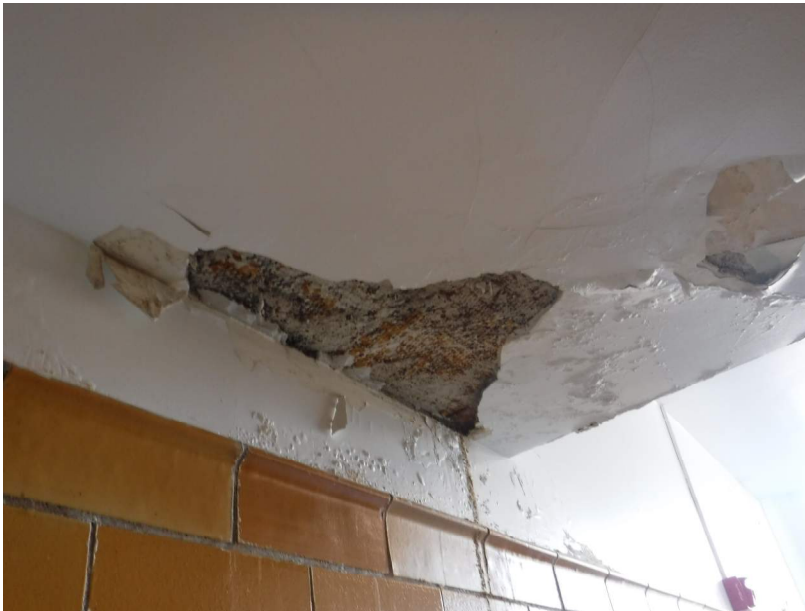
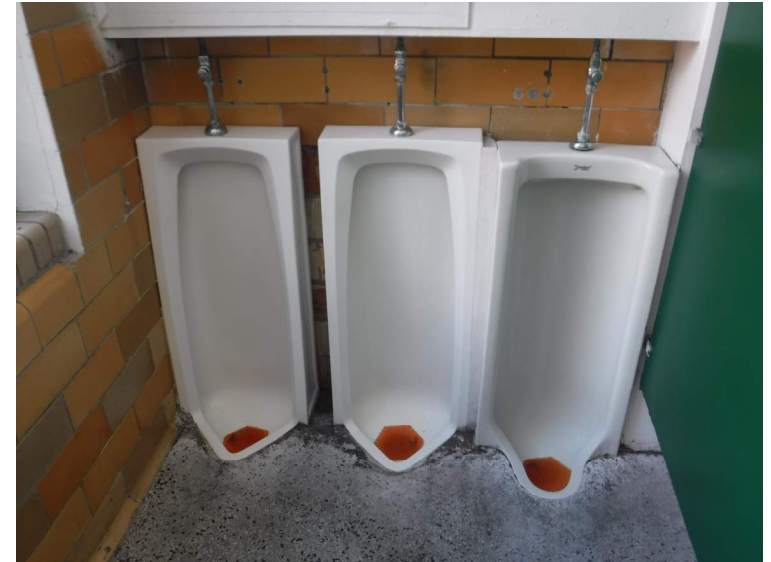
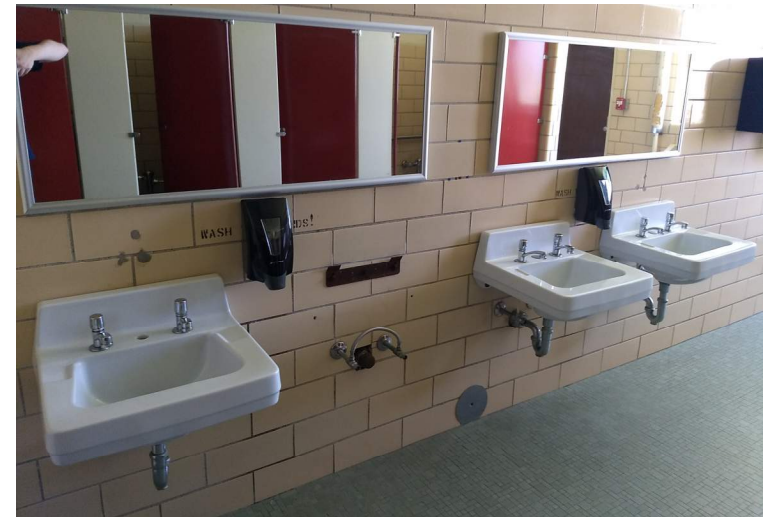
- **Restrooms:** Many of the restrooms have worn or broken finishes, missing fixtures, missing or broken equipment, poor water pressure and are not ADA compliant

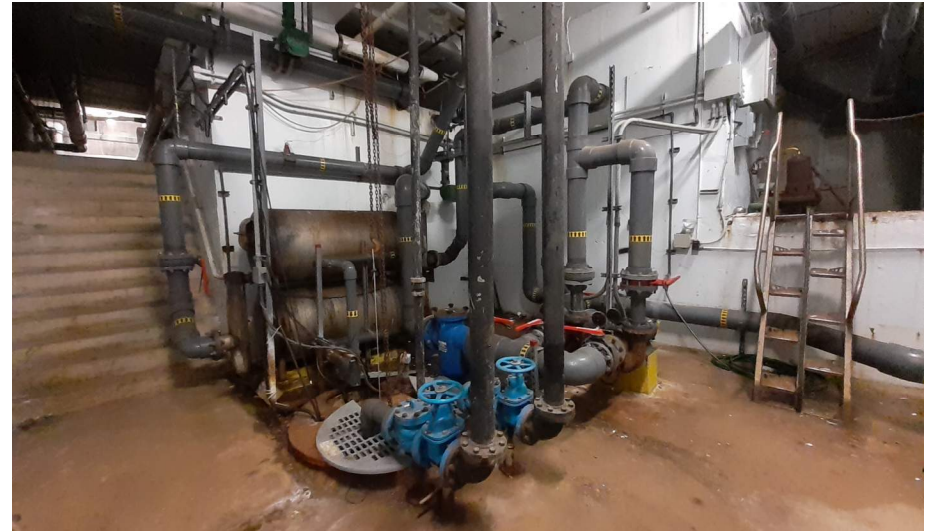
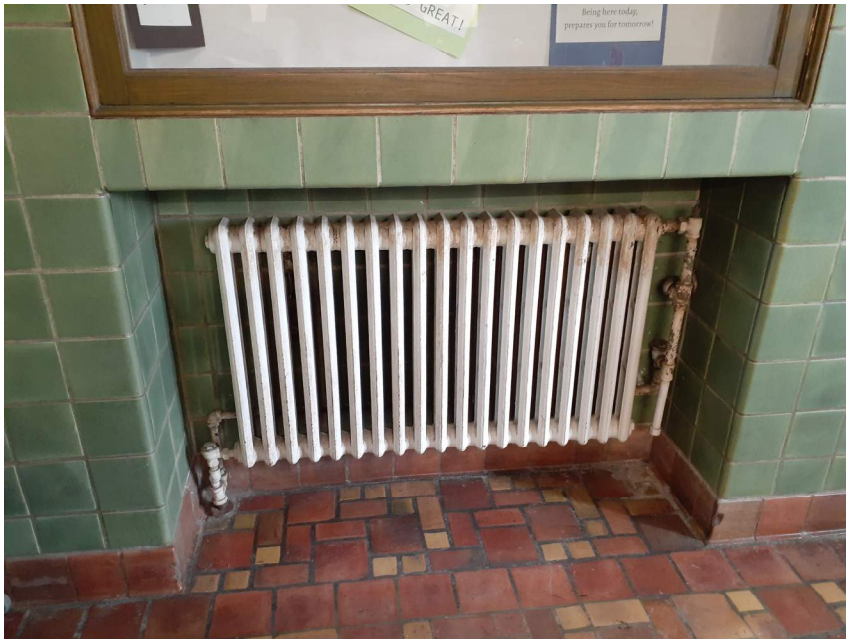
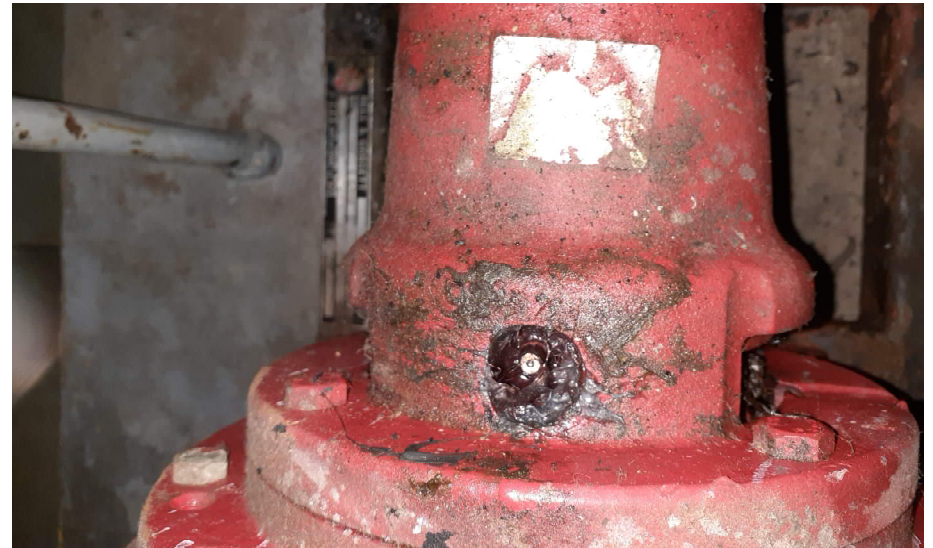
- **Mechanical:** Aging boiler and heating equipment, deteriorating piping, inadequate ventilation, broken pool equipment

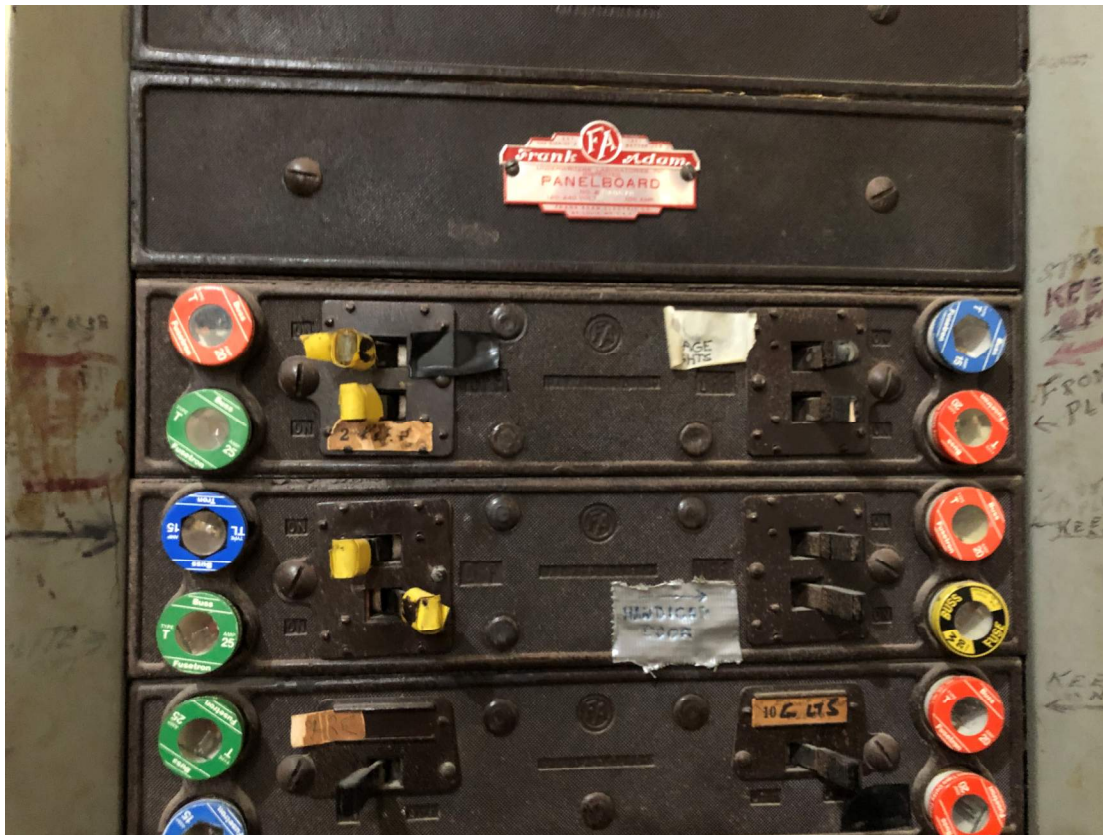
- **Electrical:** Aging electrical distribution equipment, deteriorating electrical components, inadequate site lighting
